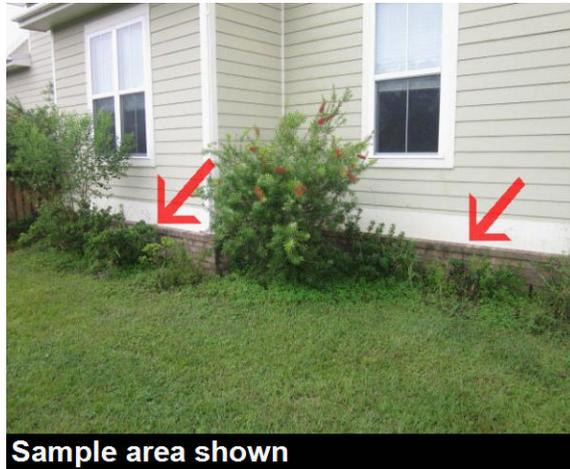
No visible flashing where the exterior side walls meet the brick. This can allow moisture inside unless properly flashed and or sealed.

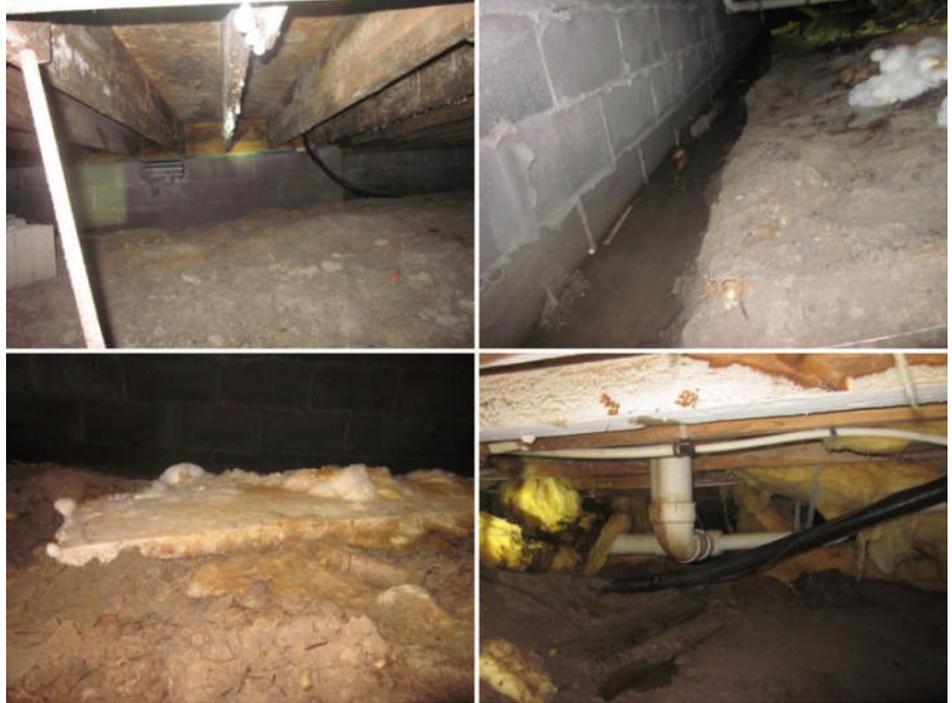
Water has been entering into the crawlspace from both the exterior and the master shower. Over time this has caused water damaged framing, insulation, flooring and extensive mold.

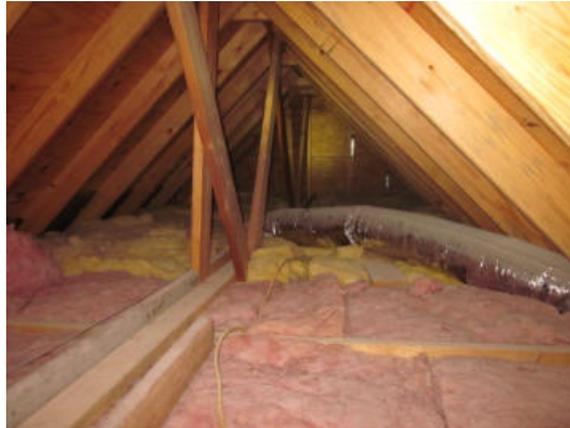
Attic was only partially observed due to construction / framing design.

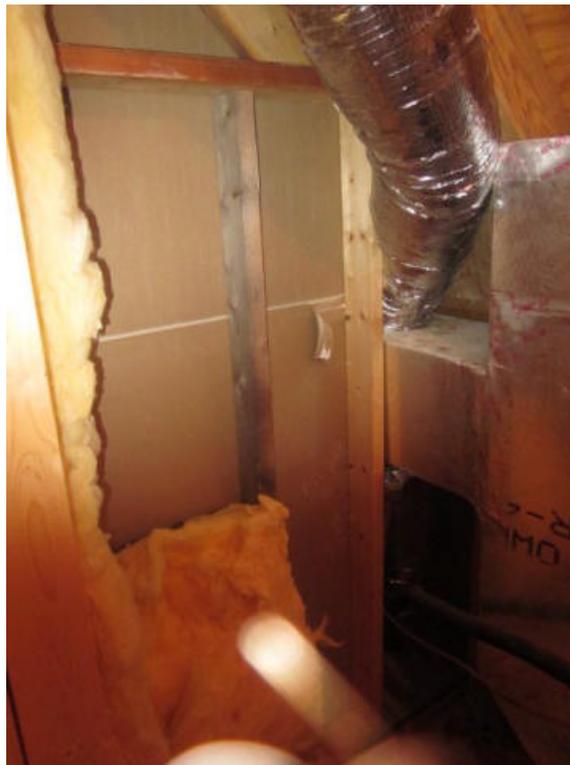
Fiberglass batts (Blanket)
Insulation is out of place in the 2nd floor attic at the north closet.

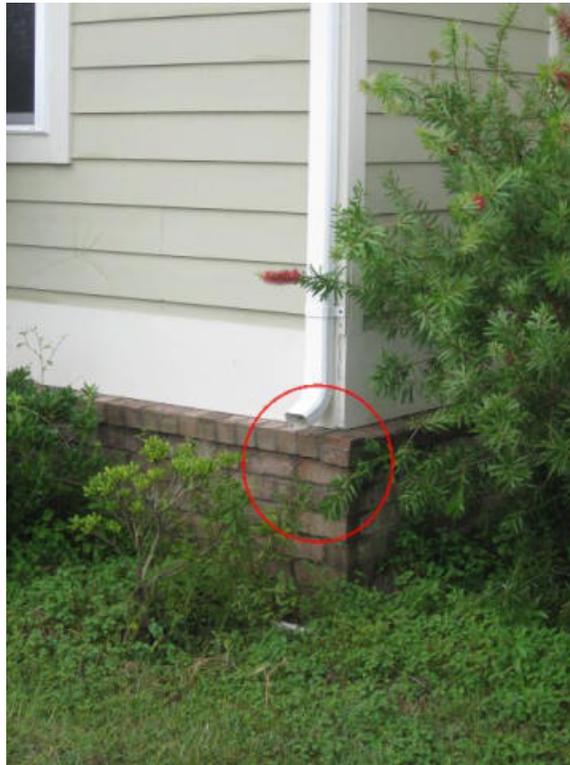
Plastic, overall general condition is OK.

Route downspouts away from the building. Ideally the water will be directed 3+ feet away from the foundation.

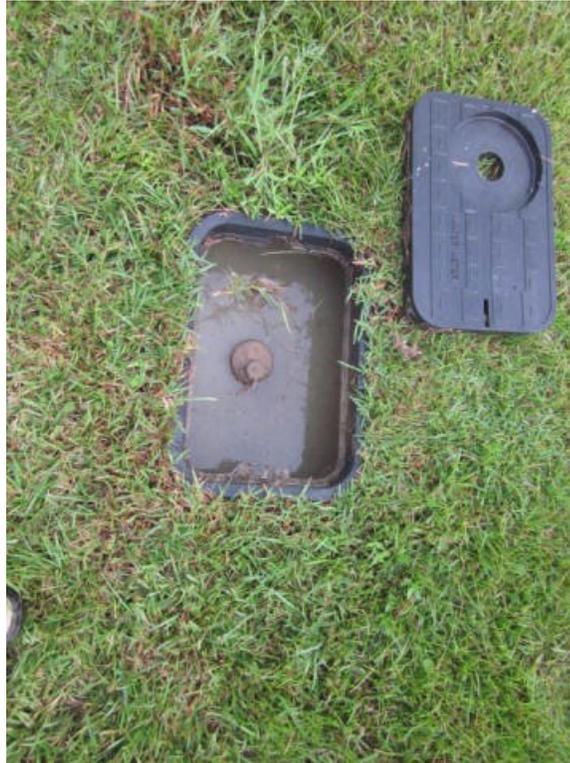
Water meter is located at the front side of the house
There is water inside the meter box. Since the meter is not moving, it is likely due to a high water table and recent rains. Recheck after it is dry for a few days.

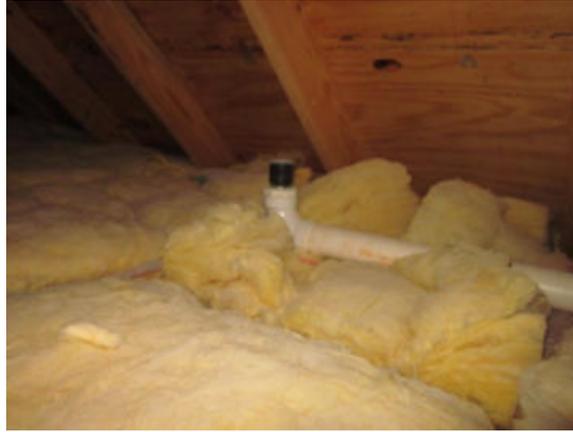
The wrong style valve has been installed in the attic. The problem arises when builders or plumbers install what is called a Mechanical Vent in place of an Air Admittance Valve or AAV. Mechanical vents are not allowed in residential homes, only the AAV should be used.

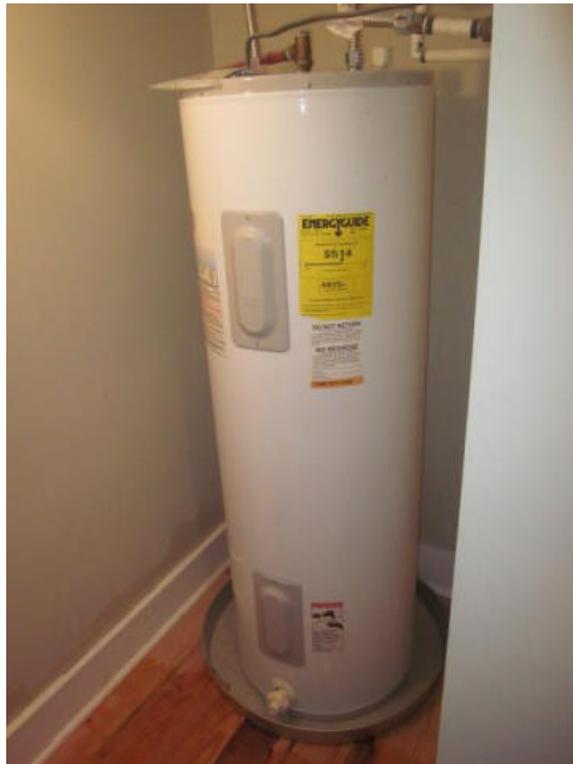
Operational at this time, The temperature setting(s) is between 120F and 125F degrees which is considered safe and economical.

Wire at the water heater should be installed into a conduit for protection from mechanical damage

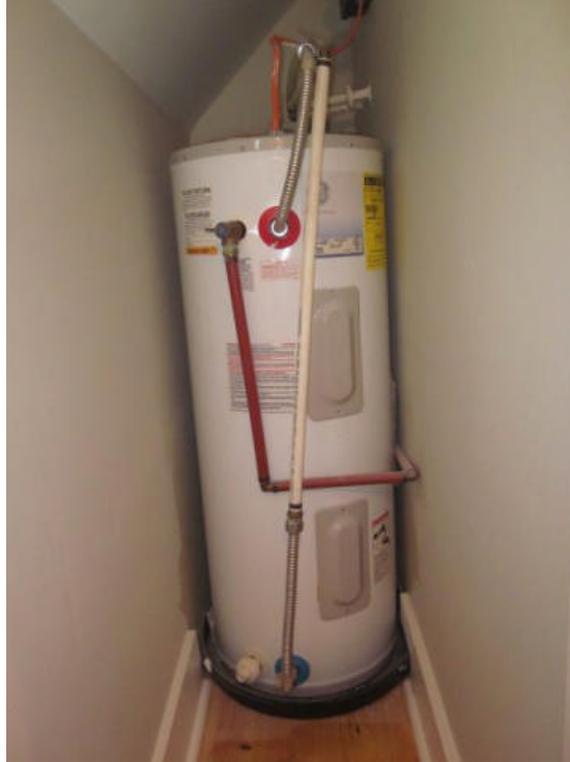
Operational at this time, The temperature setting(s) is between 120F and 125F degrees which is considered safe and economical.

Wire at the water heater should be installed into a conduit for protection from mechanical damage.

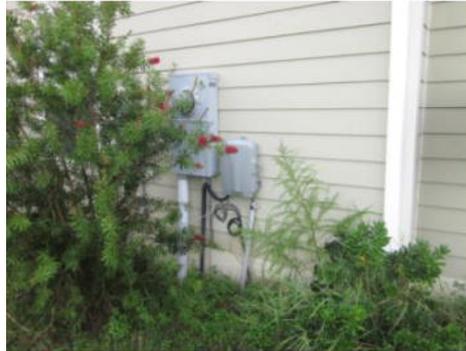
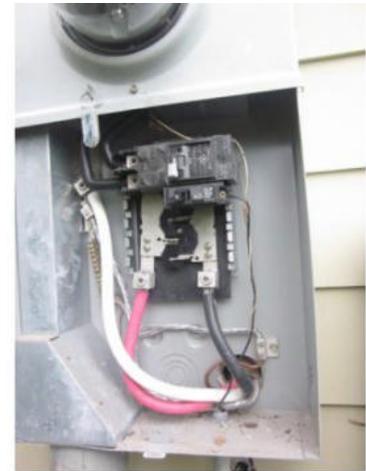
Circuit and wire sizing correct so far as visible, there is visible anti oxidant paste on the aluminum wires, I could see no signs or overheating or double taps and the panel is properly labeled

Improper clearance to access the panel. There should be 3 feet of working room clearance in front and 30 inches at the sides of the panel.

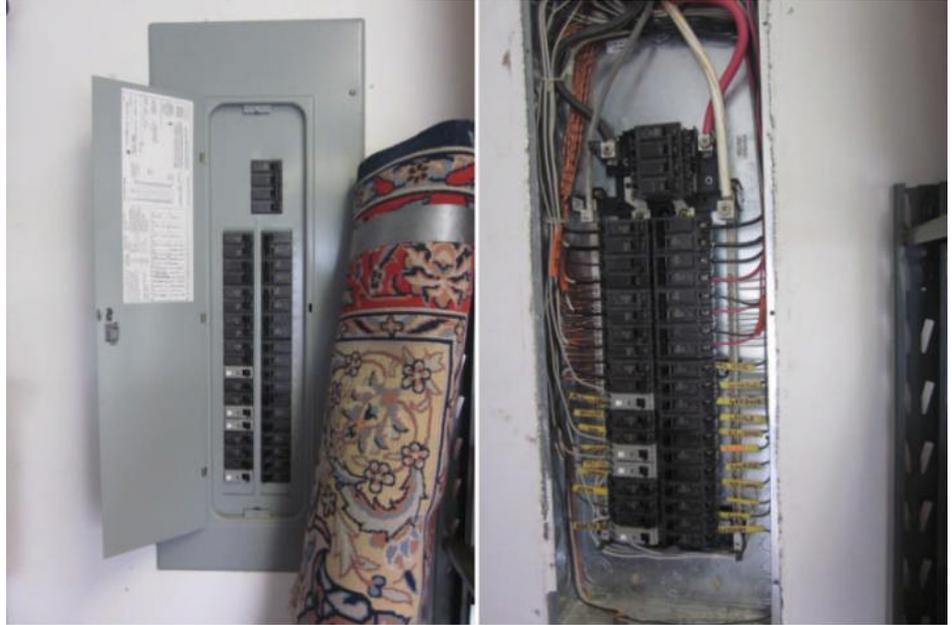
Circuit and wire sizing correct so far as visible

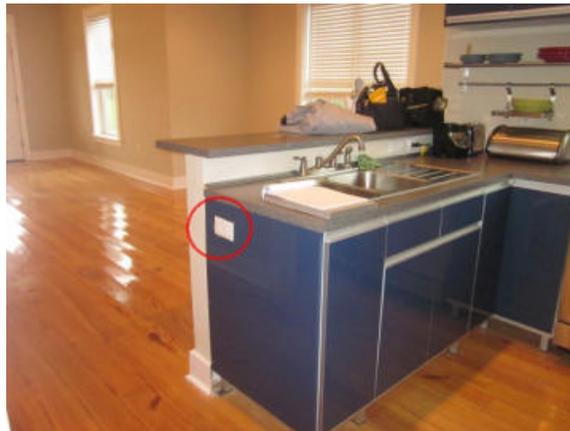
There is an outlet at the side of the kitchen cabinet. It is placed at a height that if an appliance was plugged in, a child could easily grab the power cord and pull the appliance off the counter top.

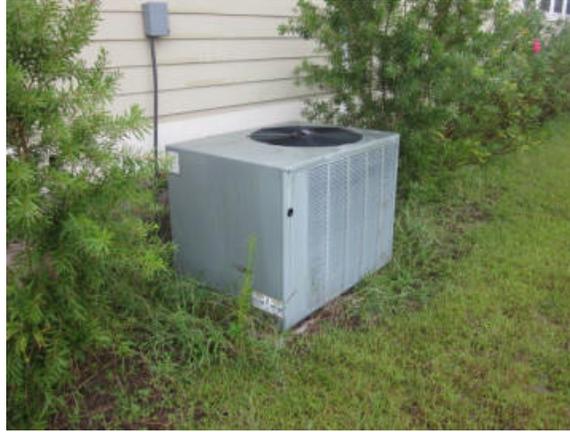
Good overall condition.

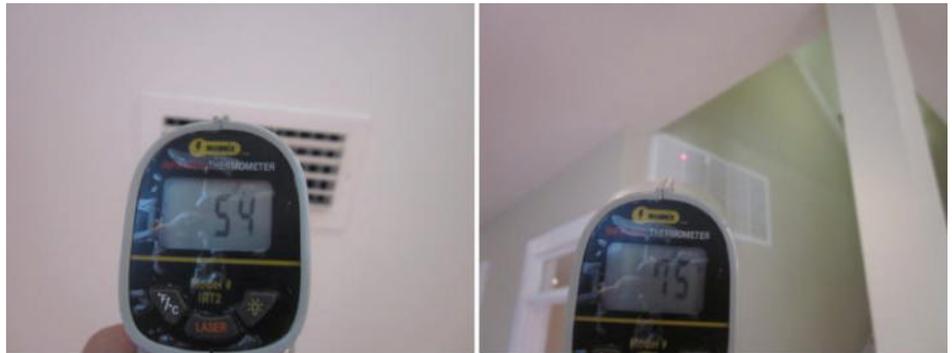
The temperature difference between the intake and register is between 12-20 degrees. This is normal for this air conditioning unit.

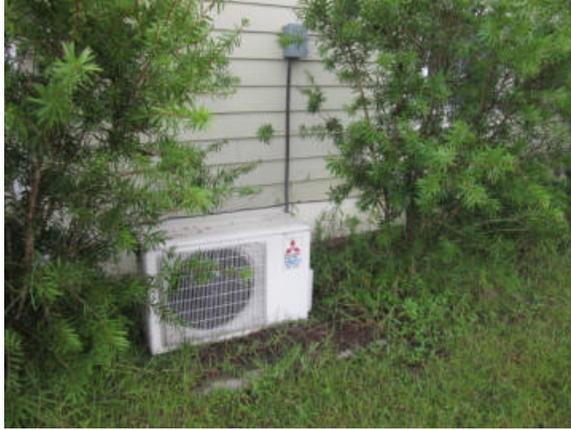
Good overall condition.

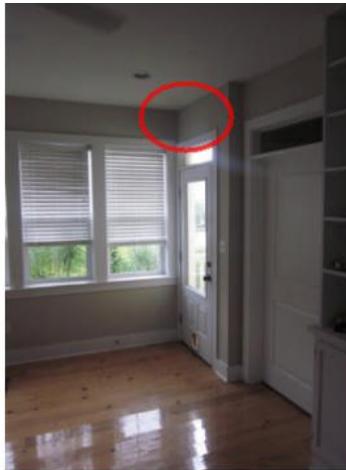
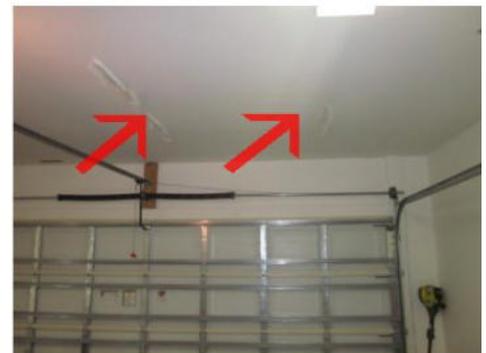
Water stains in the living room by the front door and in the garage by the overhead door. I could not confirm a cause or correction. Inquire with the seller.

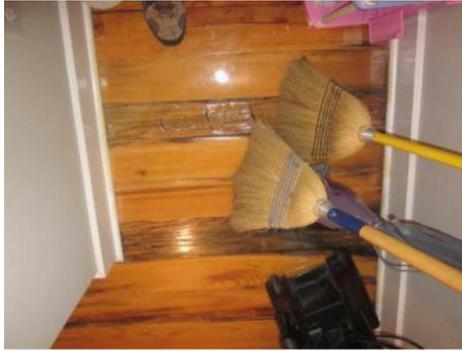
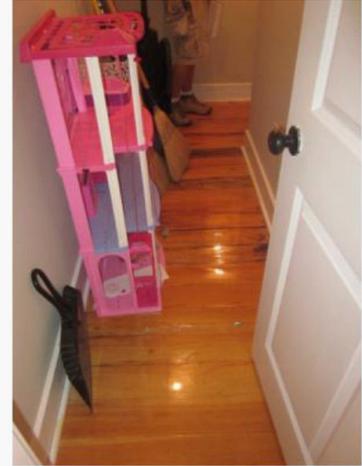
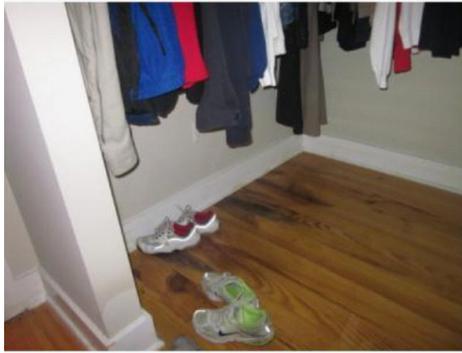
Sample areas shown

Wood flooring at the first floor is warped from moisture below.

Wood floor has some visible wood rot in the vicinity of the master shower and beyond.

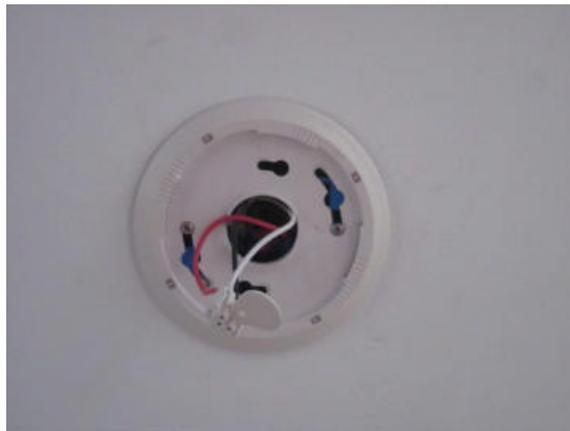
Smoke alarm(s) responded to test button operation. (It is your responsibility to make sure they are updated as required by the manufacturer and local building code.)

Smoke detector is missing in the living room.

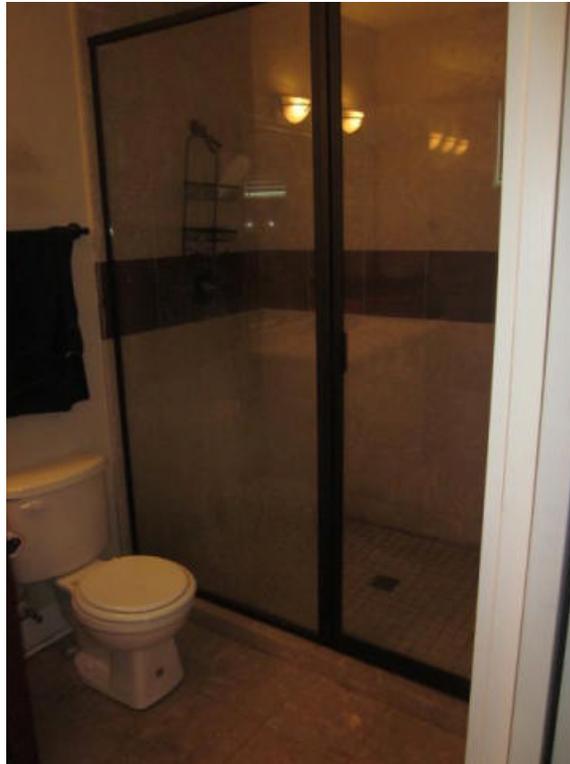
Master shower walls, floor and pan are leaking causing extensive damage to the surrounding areas and below into the crawlspace.

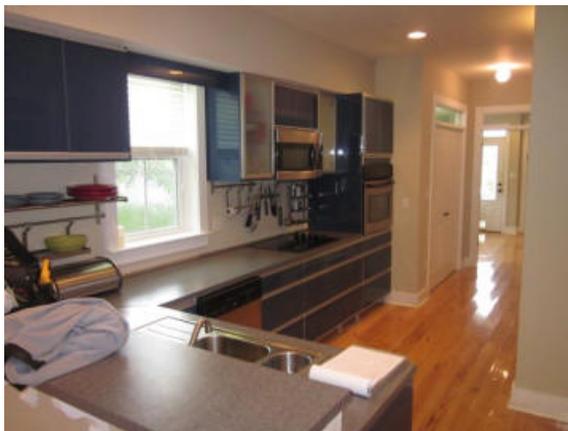
The counters, cabinets, doors, and drawers are satisfactory in both appearance and function.

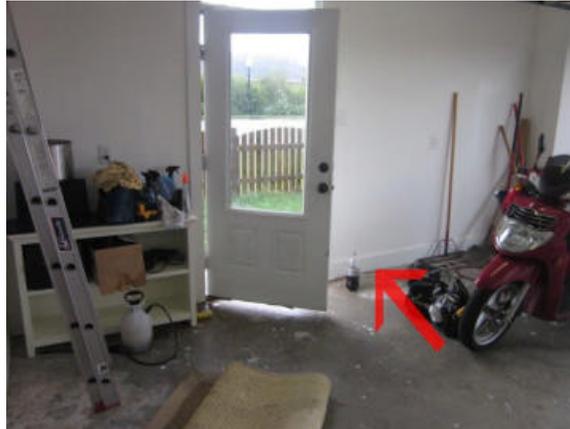
Water entering into the side garage door and vicinity.

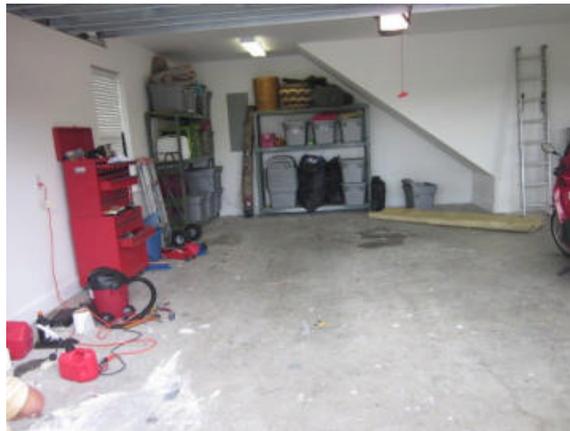
Typical cracks noted.

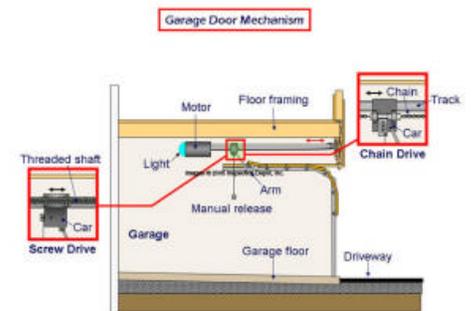
Door sensors are installed at the wrong height / place. It is recommended that the top of the photoelectric eye lens is no higher than six inches above the garage floor.

The door operates louder than normal. Adjustments and or repairs may be needed to quiet it down.

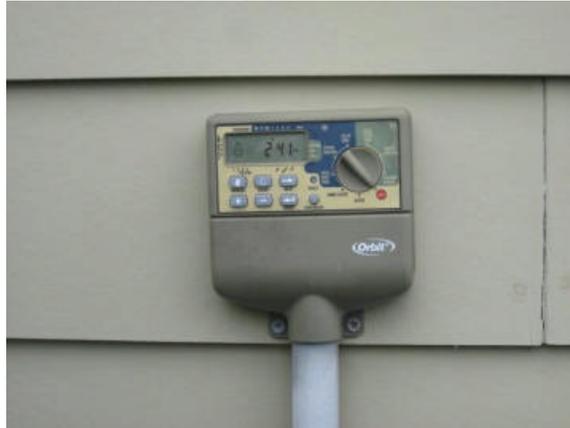
The timer is located on the exterior wall and is functioning properly at this time.

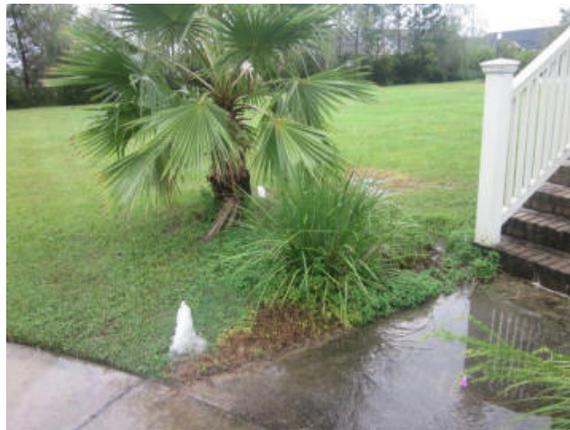
Heads are broken and I could not get enough water flow to test the sprinkler system.

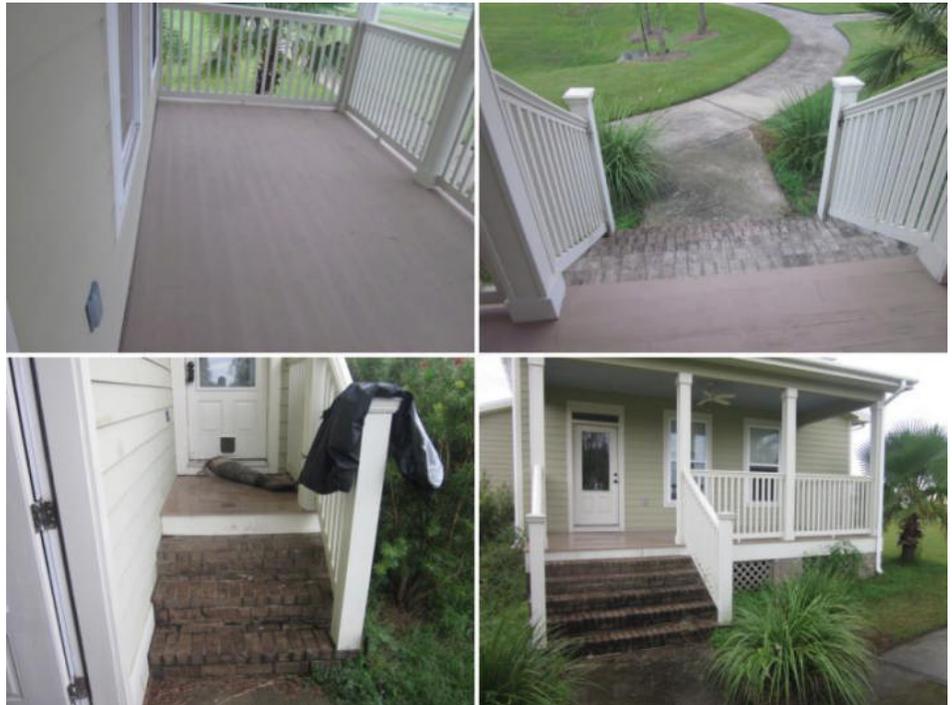
Not much of a slope of the decks away from the home.

Due to the amount of wood rot at both the front and rear decks and railings, confirm it is wood designed to be exposed to weather.

Repair wood rot at both front and rear decks and railings

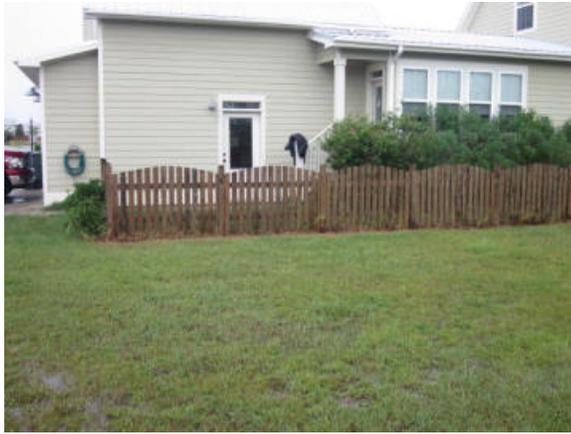
Good overall condition.

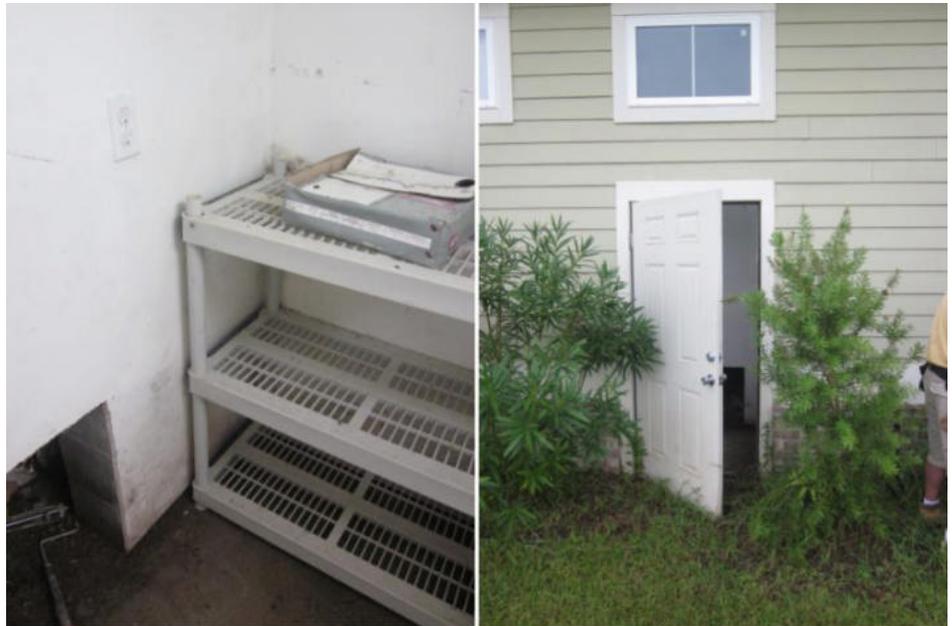
Storage shed has wood rot inside and out, at the door and there is a mold growth inside.
