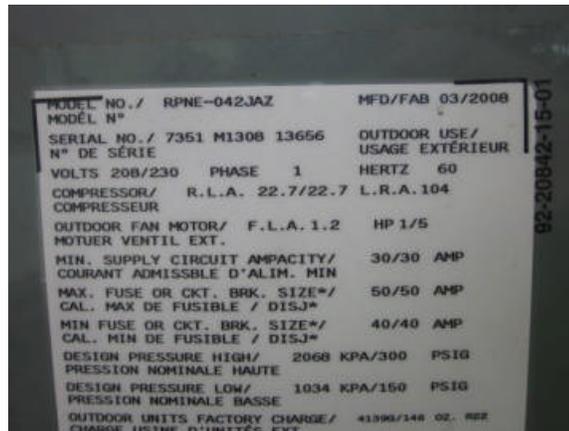
COMPRESSOR/CONDENSER BUILD DATE Unit was built in 2008 This unit typically lasts 6-10 years in this coastal environment with proper maintenance.
CAPACITY OF UNIT: 3 1/2 ton A/C SIZING: The general rule of thumb (many variances are not determined) for proper sizing of central air conditioner systems is that each ton of air conditioning will serve between 500 to 750 square feet of living area, given proper operation. The above listed tonnage figure multiplied times each of these numbers should give you a range into which the actual square footage of the house should fall. Many allowances should be made for building types, age, windows, insulation, etc.

Good overall condition.

The temperature difference between the intake and register is between 12-20 degrees. This is normal for this air conditioning unit.

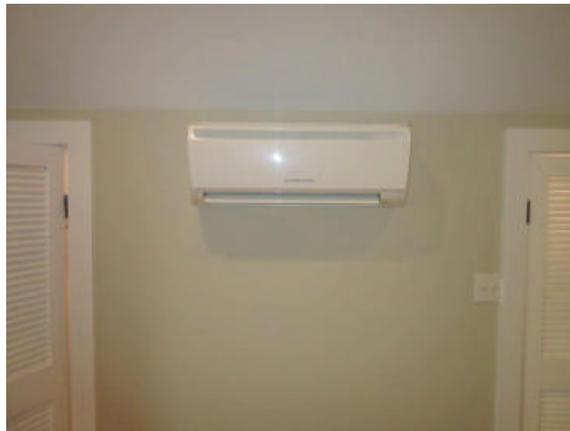
Wall Mounted split unit.

Good overall condition.
